# UNDERWATER FACILITIES INSPECTIONS & ASSESSMENTS

**UNDERWATER FACILITIES  
INSPECTIONS  
AND  
ASSESSMENTS  
AT**

**PHILADELPHIA NAVAL SHIPYARD**

**FPO-1-83-(48)      OCTOBER 1983**

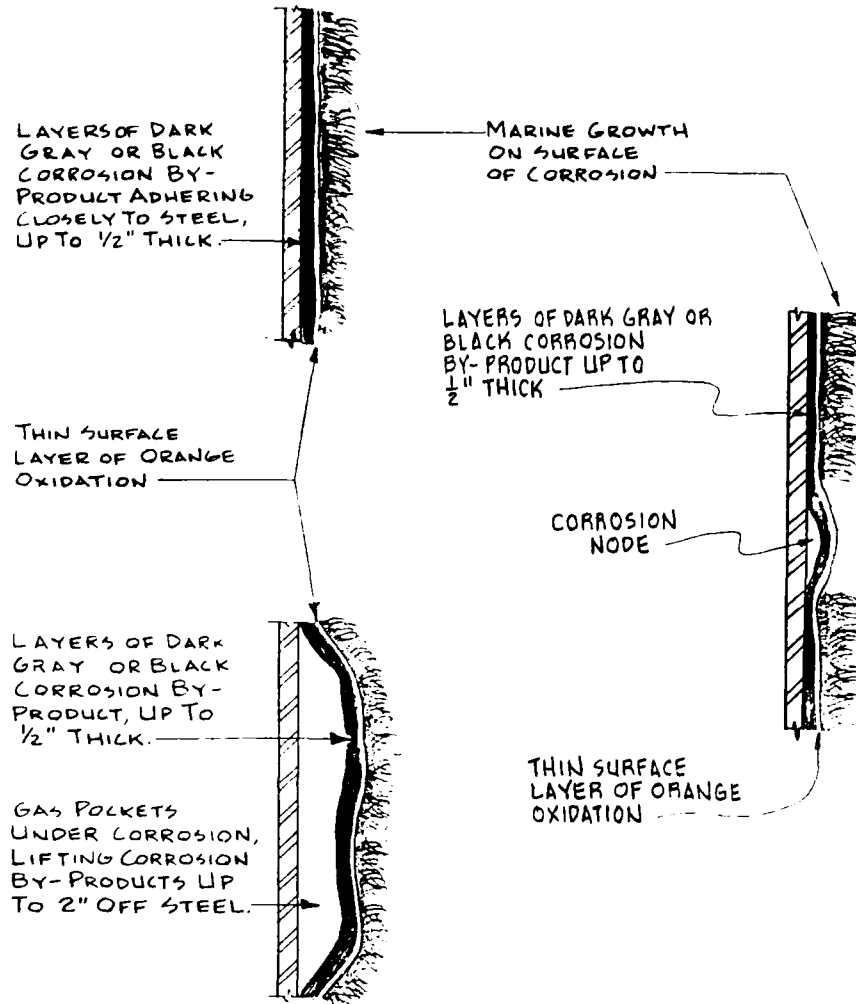
1/16" deep and 1/4" in diameter will be noted as heavy pitting (see Photo #10 and Figure 6).

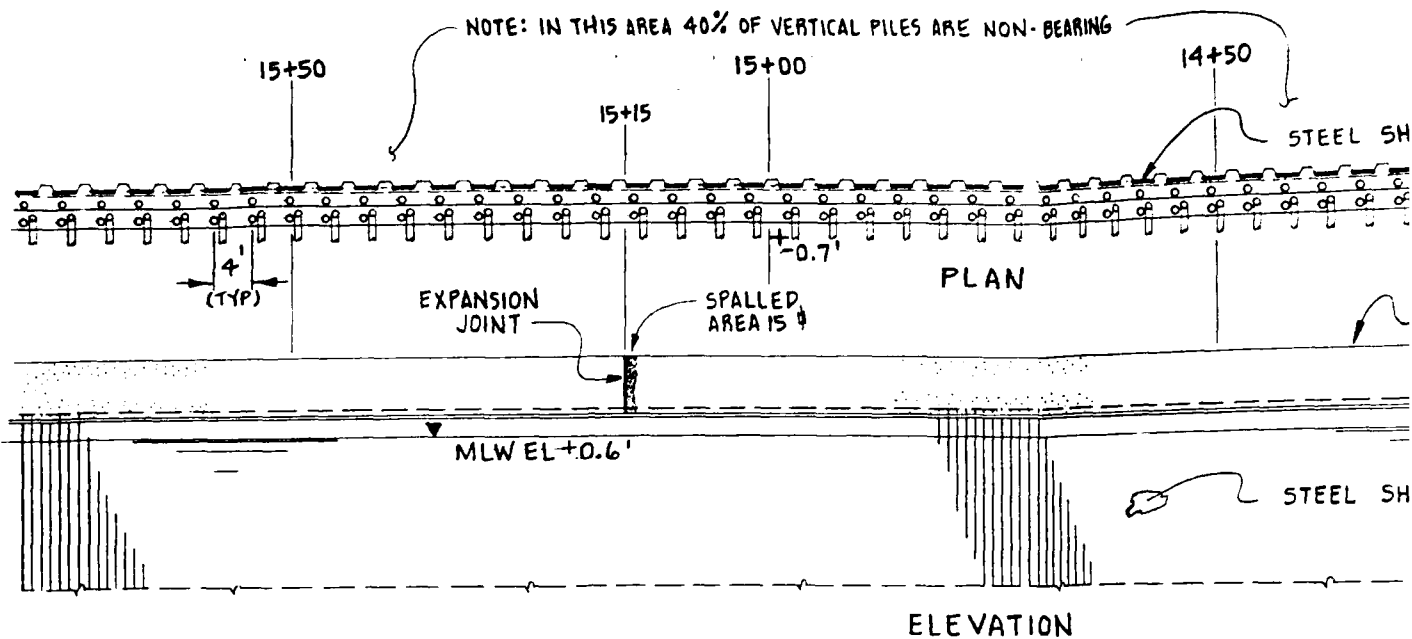
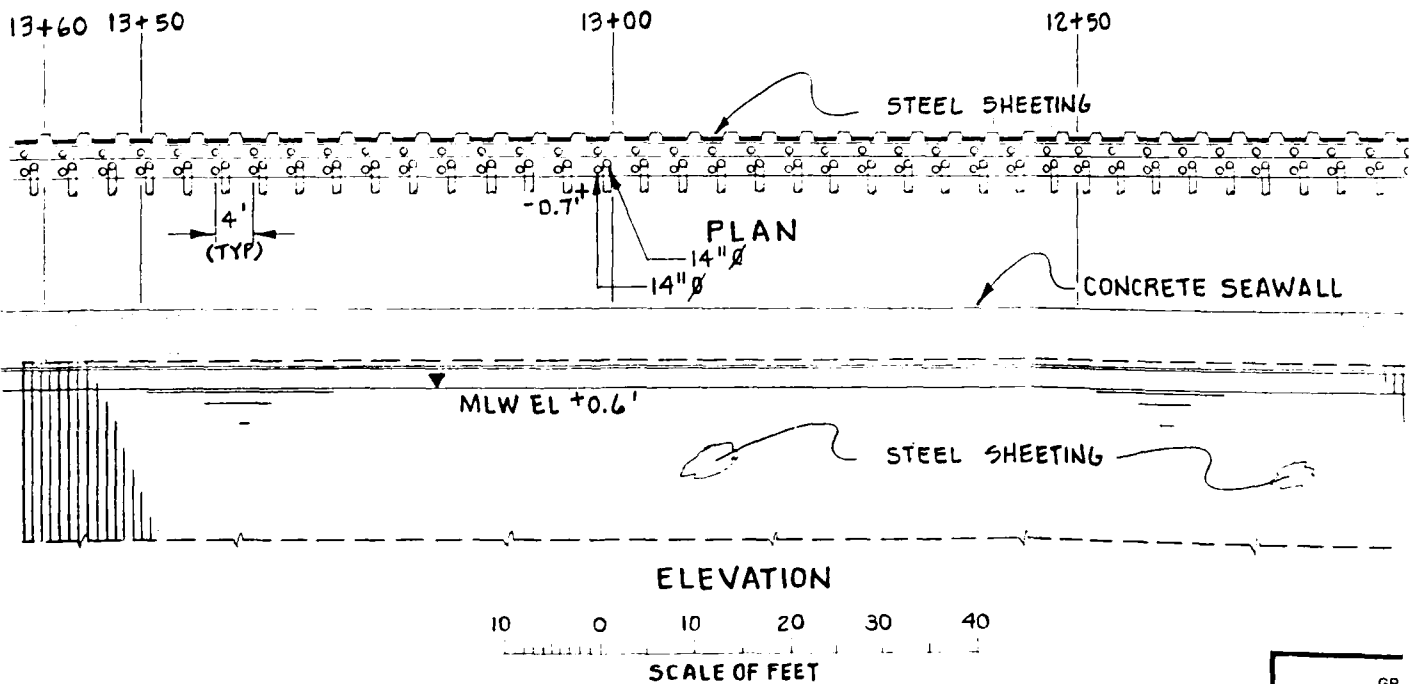
GRAPHIC SCALE	CHILDS ENGINEERING CORPORATION 828 323 MEDFIELD, MA	CHESAPEAKE DIVISION NAVAL FACILITIES ENGINEERING COMMAND WASHINGTON, D.C. PHILADELPHIA NAVAL SHIPYARD PHILADELPHIA, PA	FIG. NO. 11
AS SHOWN		EASTERN SEAWALL

the piles being non-bearing (see Figures 11 through 15 for locations).

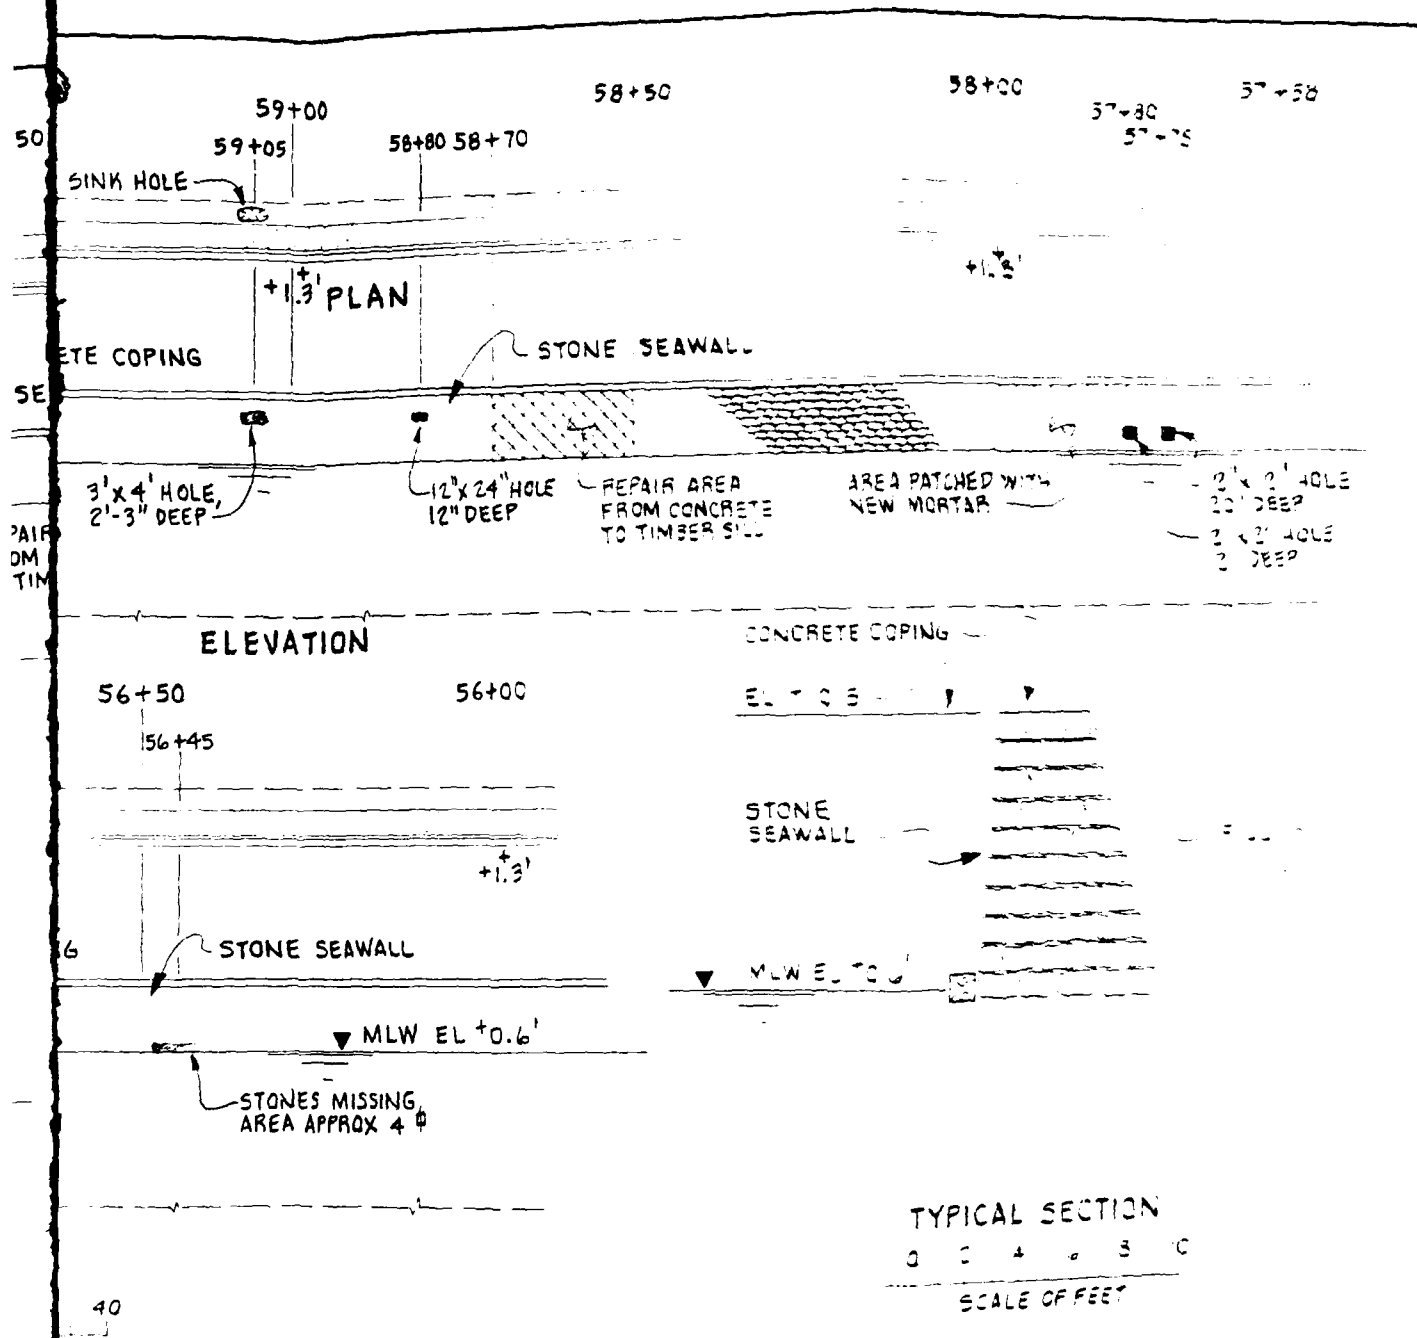
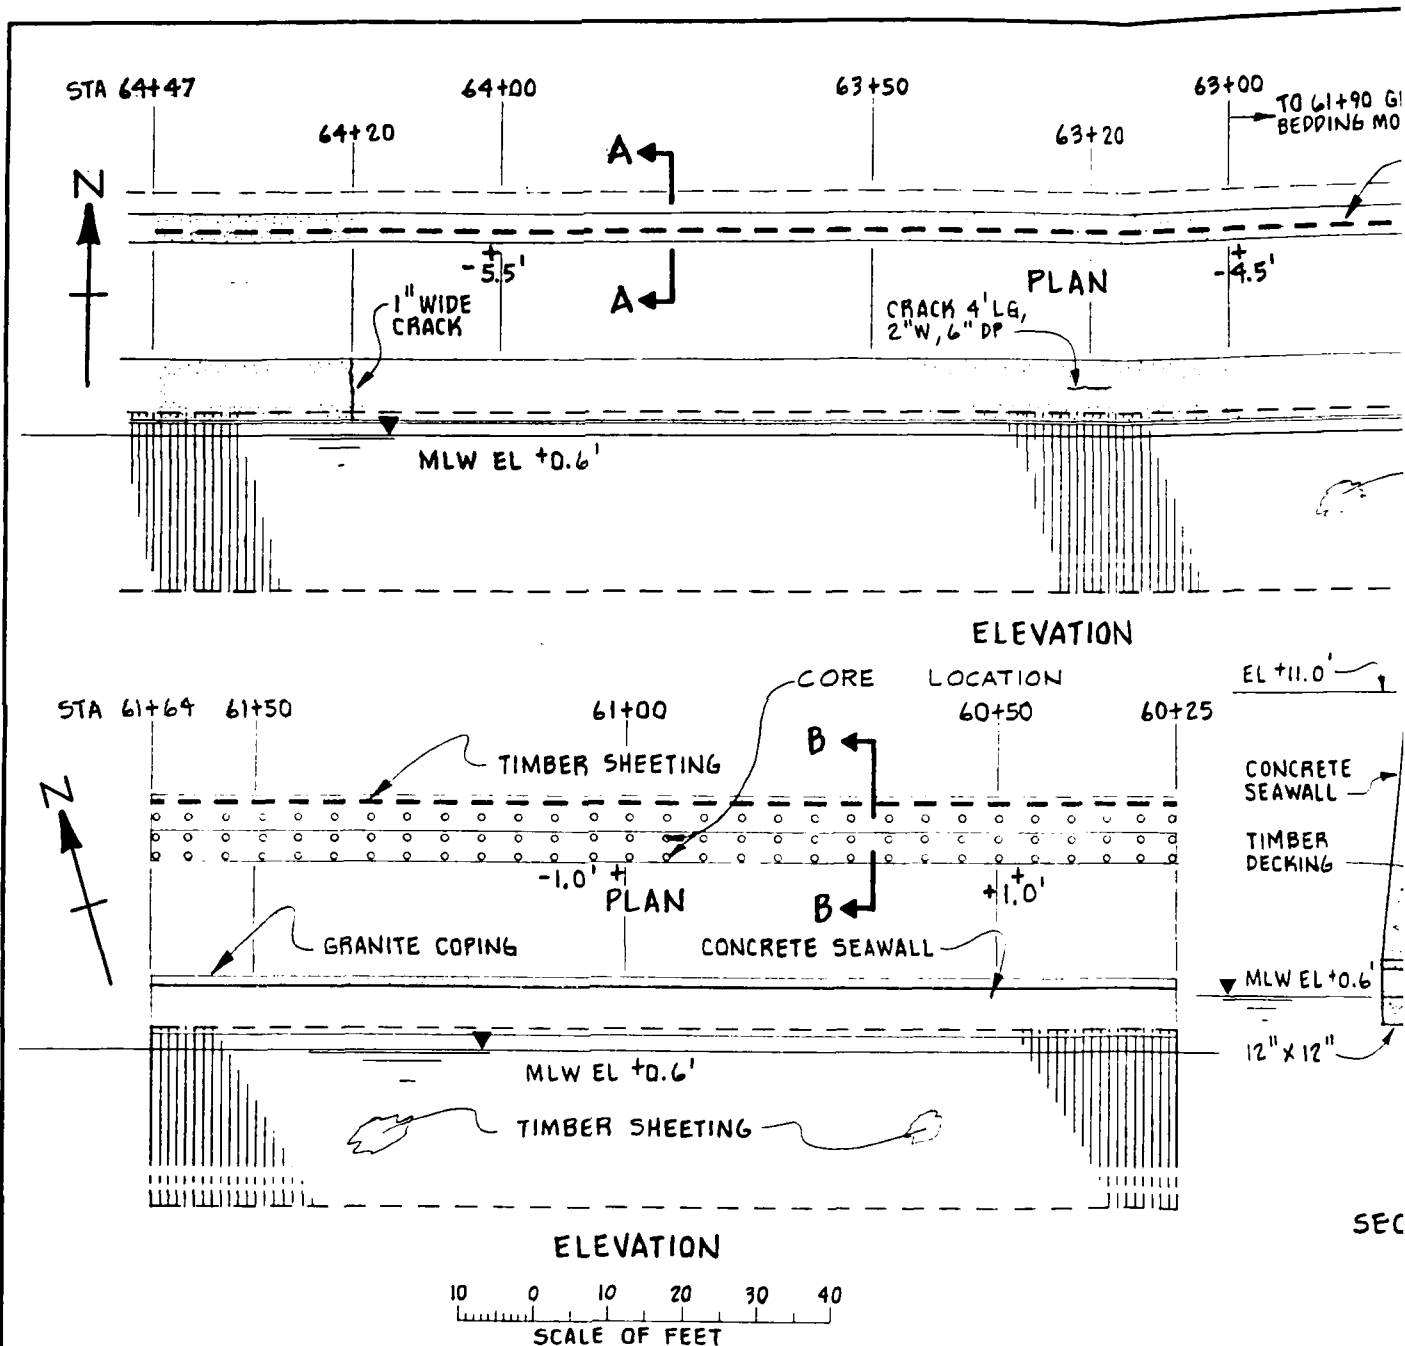
GRAPHIC SCALE	CHILD ENGINEERING CORPORATION 304 333 WILMINGTON, MA	CHESAPEAKE DIVISION NAVAL FACILITIES ENGINEERING COMMAND WASHINGTON, D.C.	
AS SHOWN		PHILADELPHIA NAVAL SHIPYARD PHILADELPHIA, PA	22

Along the stone seawall between Station 52+35 to Station 60+25, there is no mortar remaining between the stones. Also there are areas along the wall (see Figure 22) where stones are missing leaving voids or holes ranging from 6" in depth to 3' in depth. Previously patched areas along the wall are beginning to deteriorate at the lower elevations.

The previously described condition of the stone seawall (Stations 52+35 to 60+25) is caused by the frequent wetting/drying and freeze/thaw along with the wave and chemical action (sulfate attack) that occurs in the tidal zone.

The stone seawall between Station 52+35 and Station 60+25 should be pointed and the loose and missing stones should be replaced. The estimated cost per linear foot of seawall is \$40.00. The total estimated cost is approximately \$32,000.

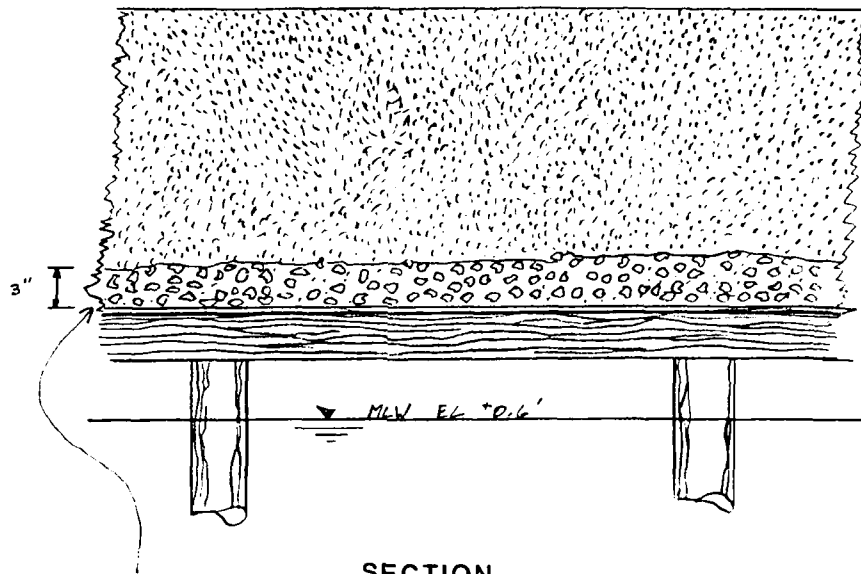
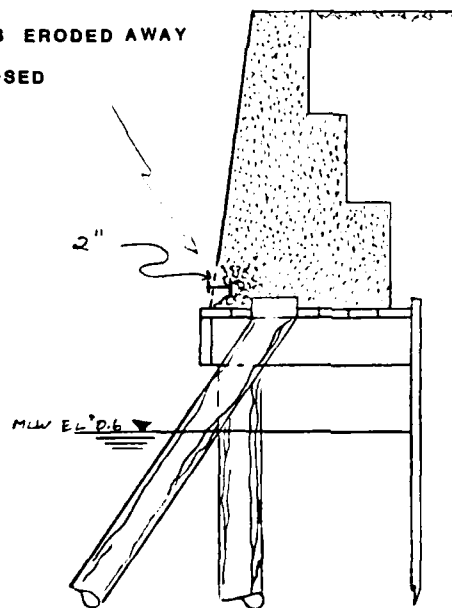
There is no functional fender system along the full length of the seawall. The concrete seawall showed only minor spalling generally limited to the MLW elevation. This spalling is exemplified by the loss of the fine aggregates and cement while leaving the larger aggregates in place (see Figure 25 and Photo #13). There is some vertical cracking in the seawall at various locations.

# CONCRETE AGGREGATE EXPOSED

CONCRETE FINES ERODED AWAY  
AGGREGATE EXPOSED

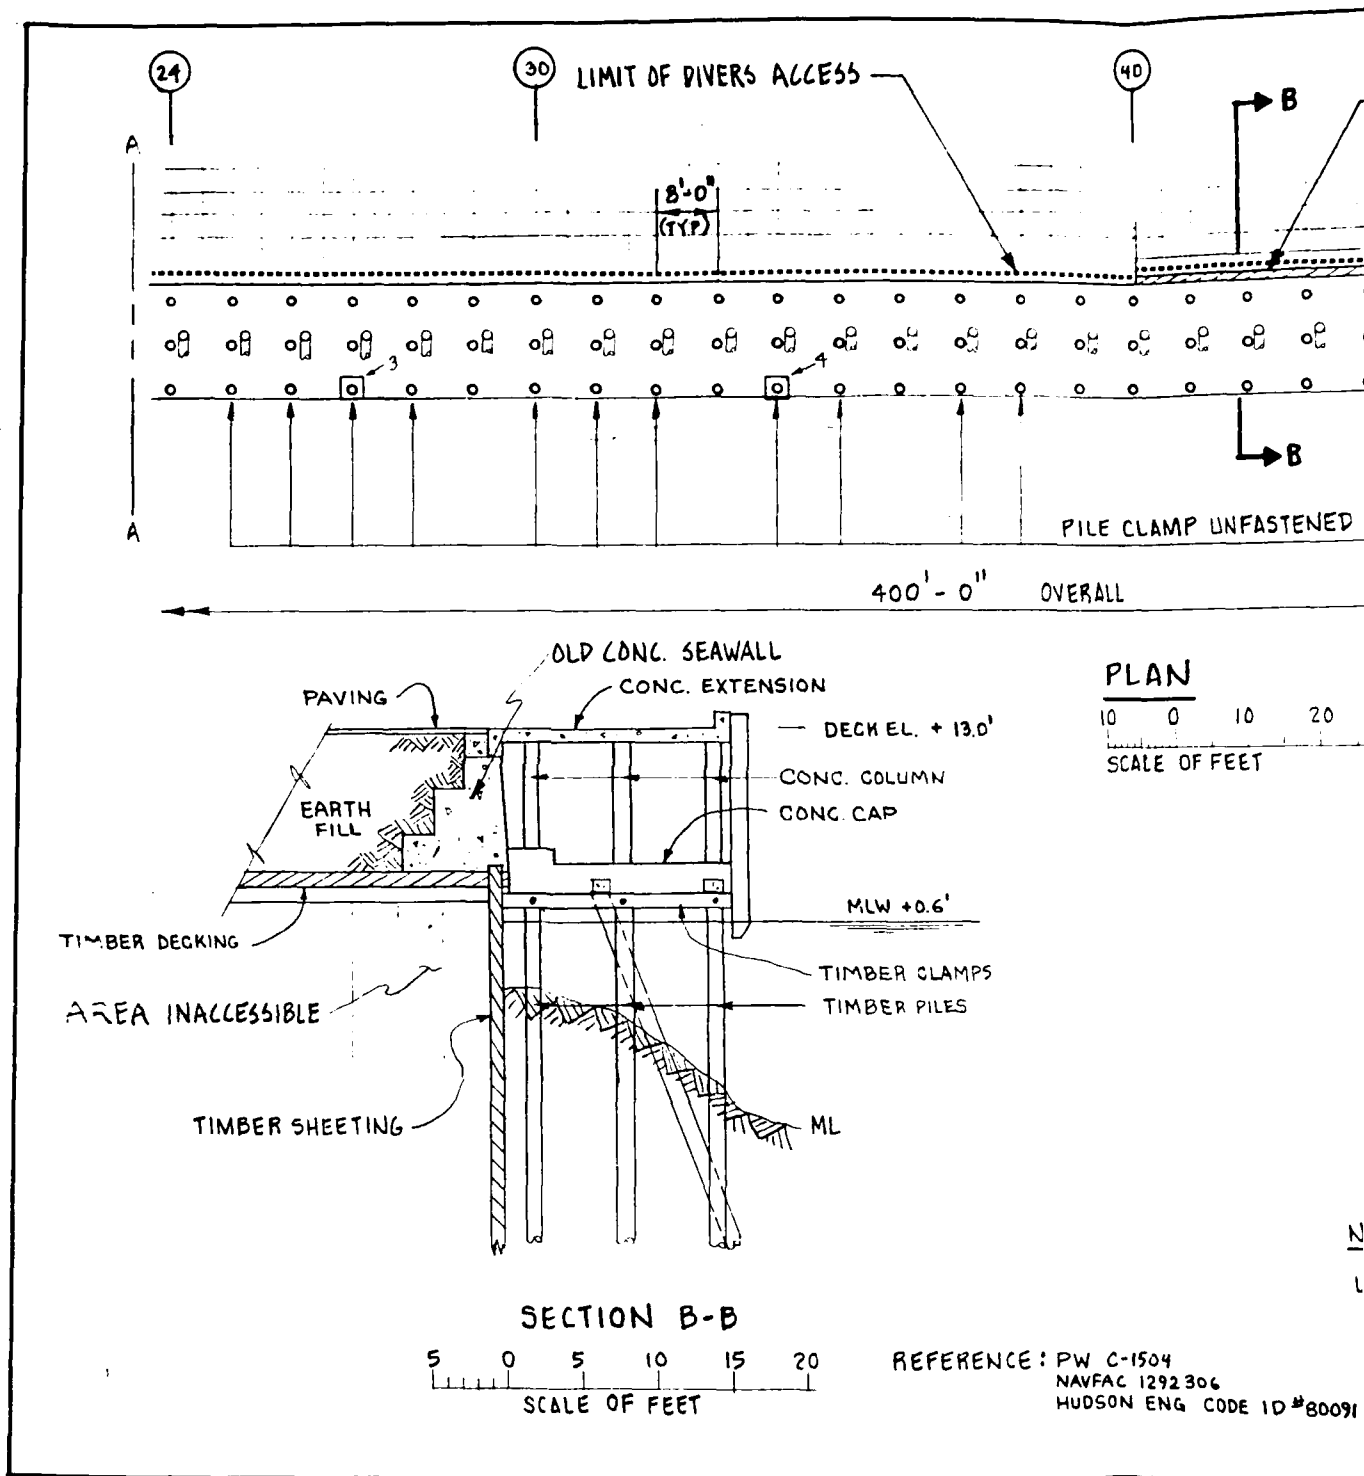
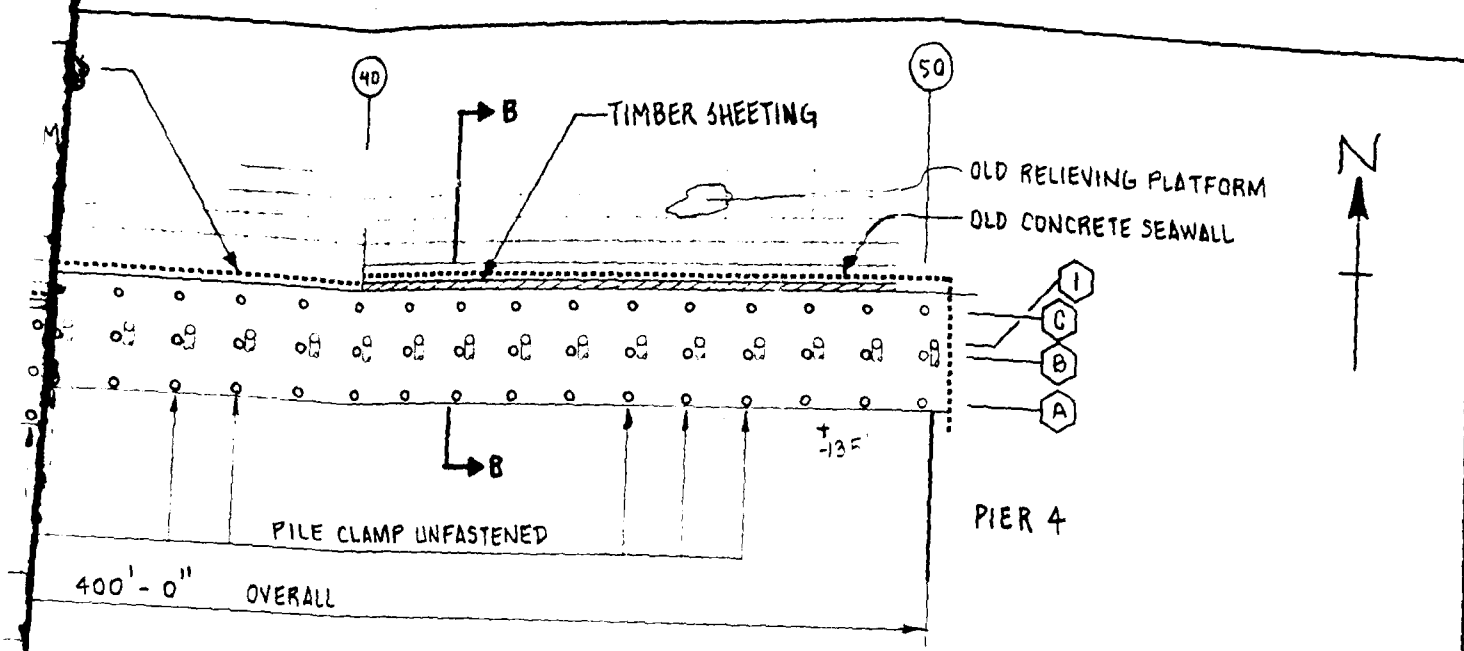
MANY CONCRETE COLUMNS HAVE BEEN REPAIRED BY GUNNITE.

The timber clamps (non-structural) used to align the pile bents are becoming unfastened and falling away from the piles (see Figures 35 and 36 and Photo #24). Otherwise the fasteners connecting the batter piles to the longitudinal beam are in excellent condition (see Photo #25).

The concrete superstructure appears to be in good condition. There have been some repairs made on the concrete columns (see Section B-B, Figure 36) and beams using pneumatically-placed concrete. These repairs are in excellent condition. On Bents 1 to 4 there are approximately 200 square feet of spalled surface area with some reinforcing bar exposed. Generally, this damaged area is located near mean low water (see Photo #26).

On Wharf 4A the spalled areas of the concrete superstructure should be repaired using pneumatically-placed concrete to provide the proper cover over the reinforcing steel. The estimated cost to cover one square foot of area and prepare the concrete surface is \$14.16. The total estimated cost would be 200 sq.ft. @ \$14.16/sf = \$2,832.

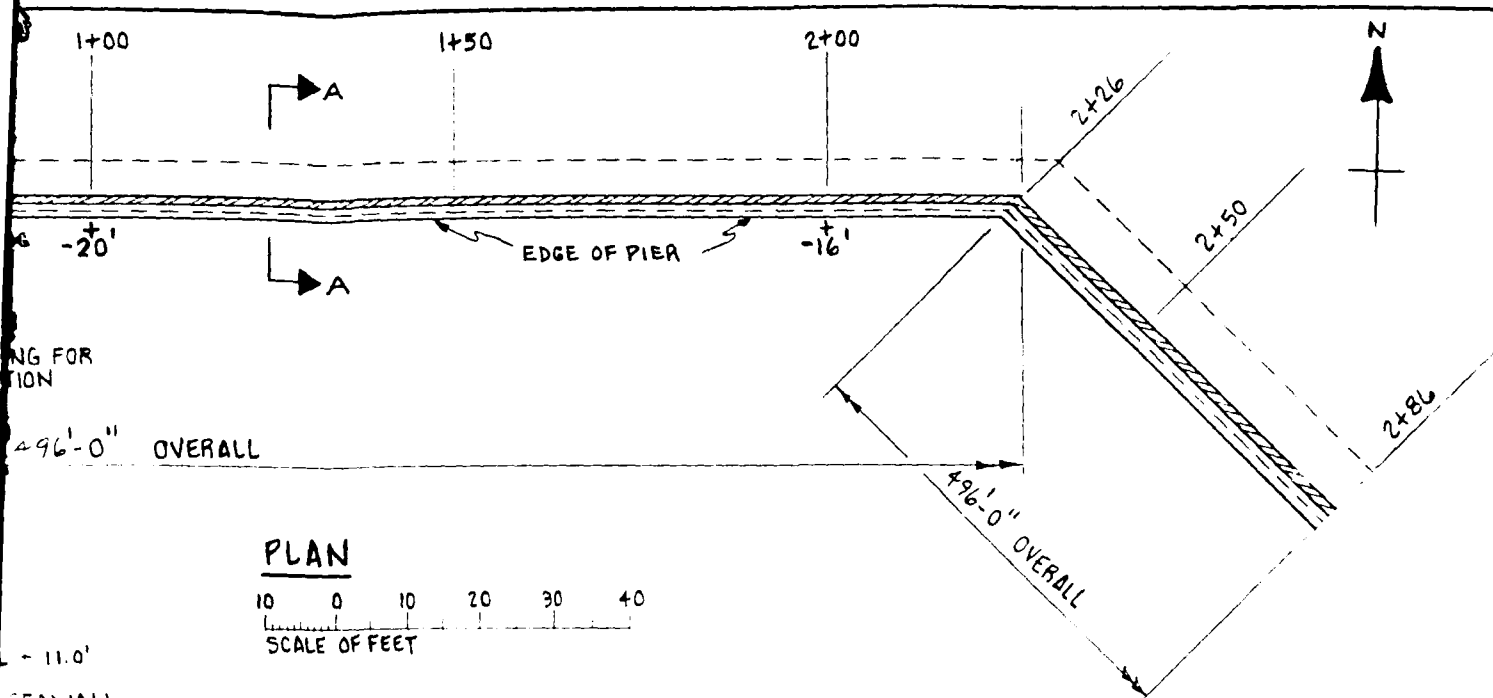
NOTE:  
SEAWALLFACE HAS BEEN REPAIRED WITH GUNITE

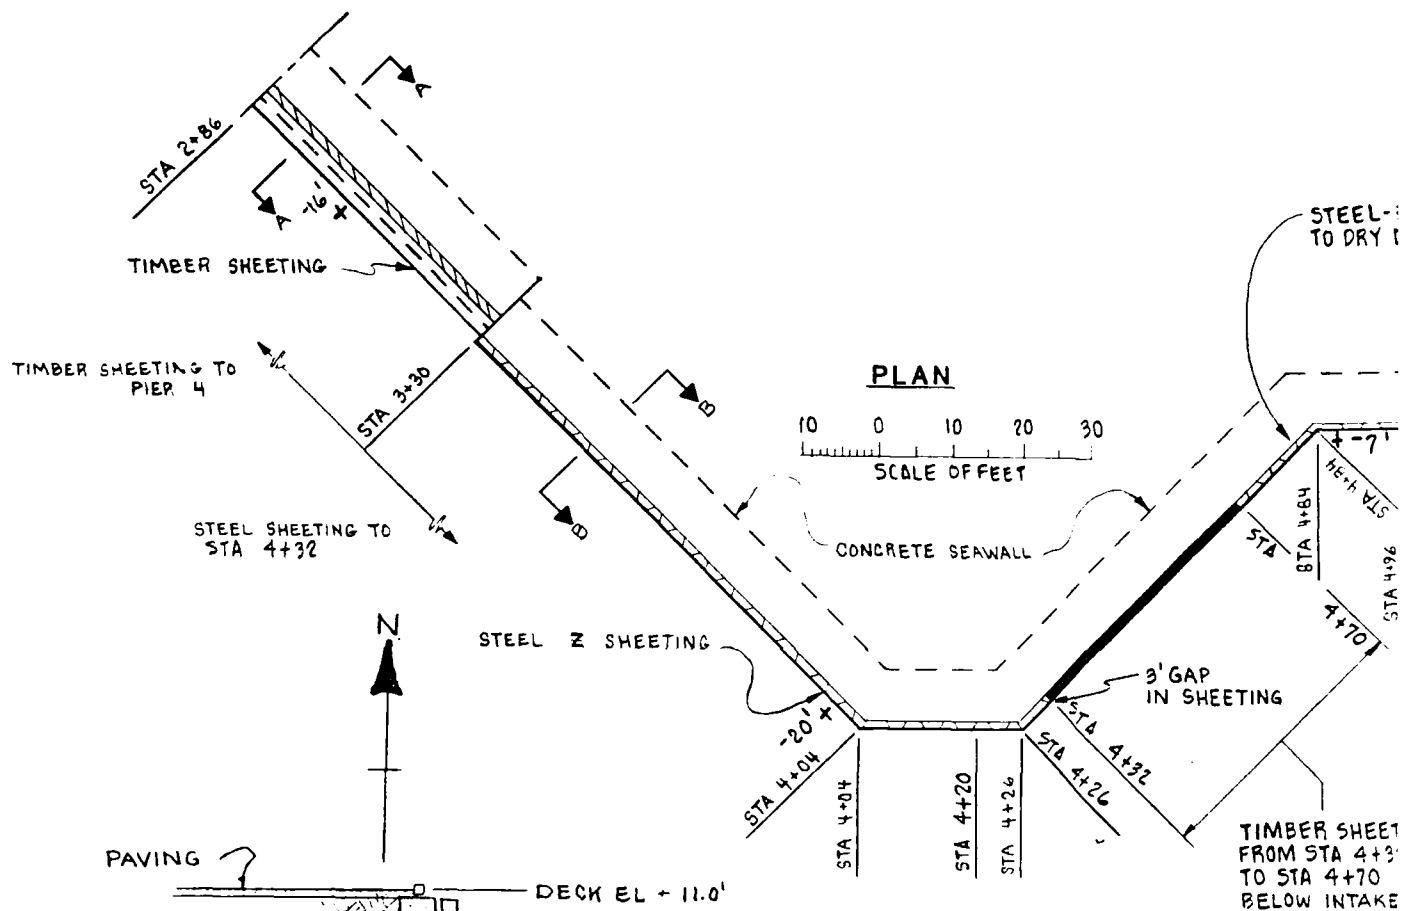
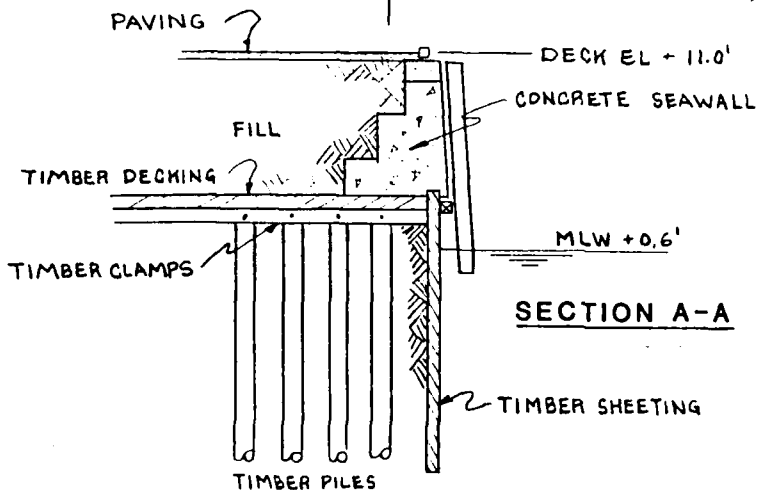
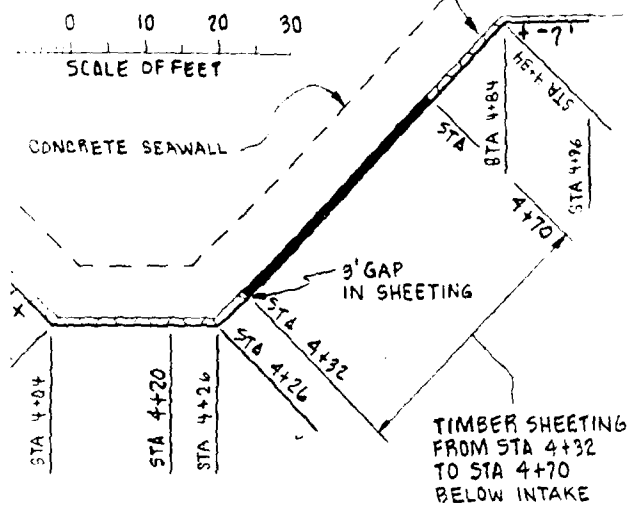
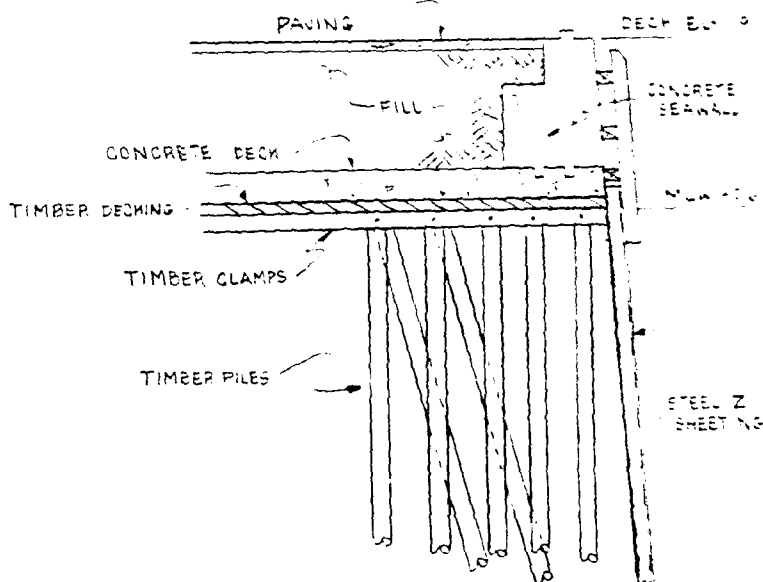
The surface of the steel sheet piling is very rough and pitted. The outer layer of corrosion is a soft orange corrosion by-product with pockets of trapped gas. Closer to the surface of the steel is a harder black layer of corrosion by-product. Pits are as deep as 1/16". Steel thickness readings (see Figure 38) show that there is minimal loss of steel due to corrosion (see Photo #29).

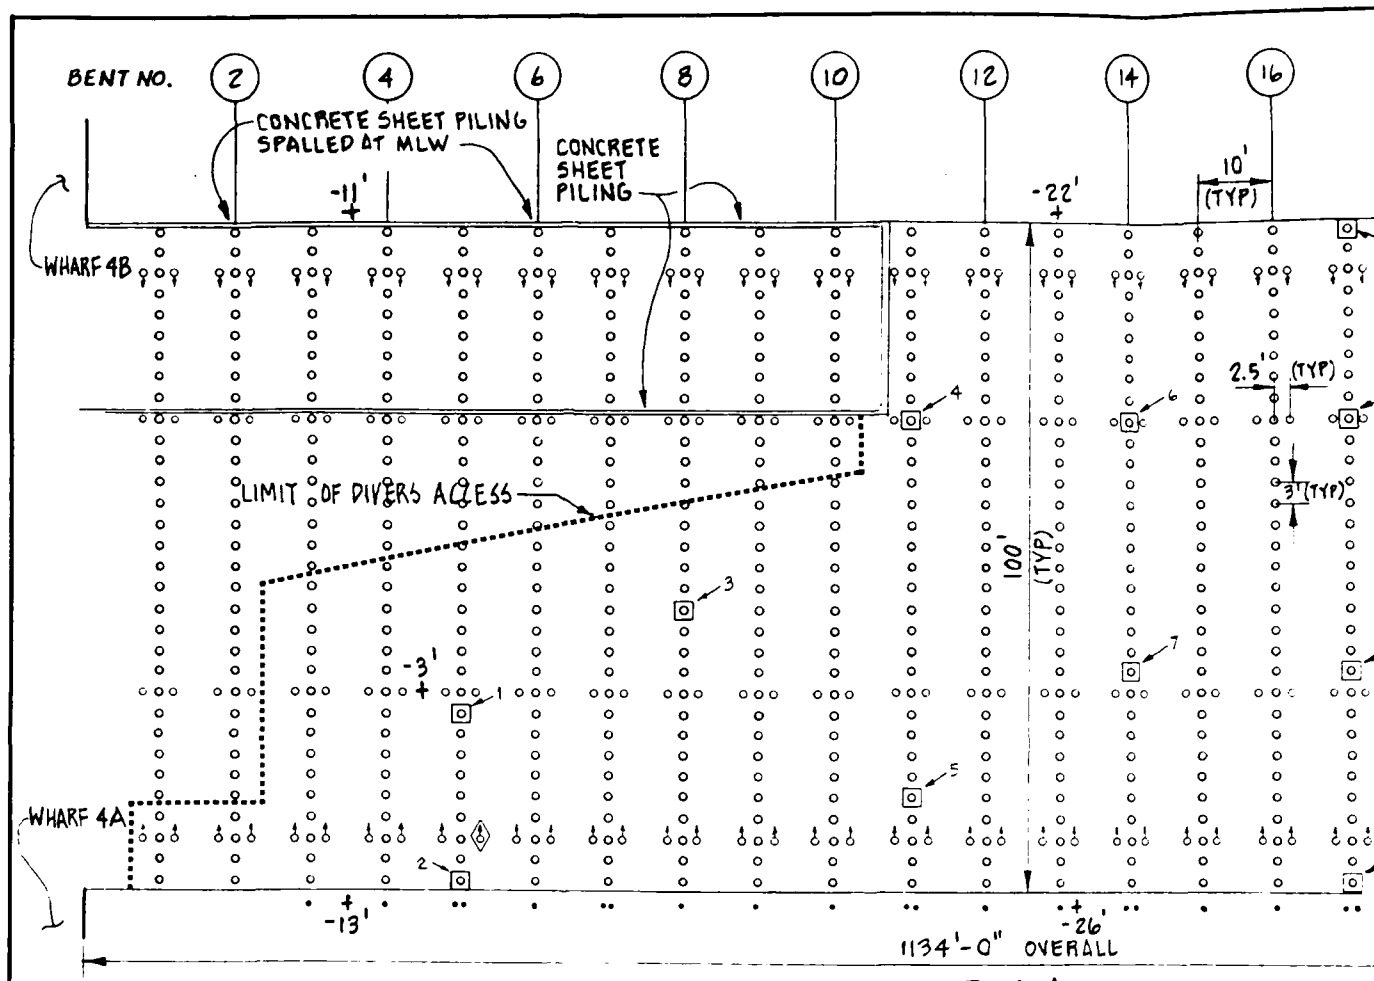
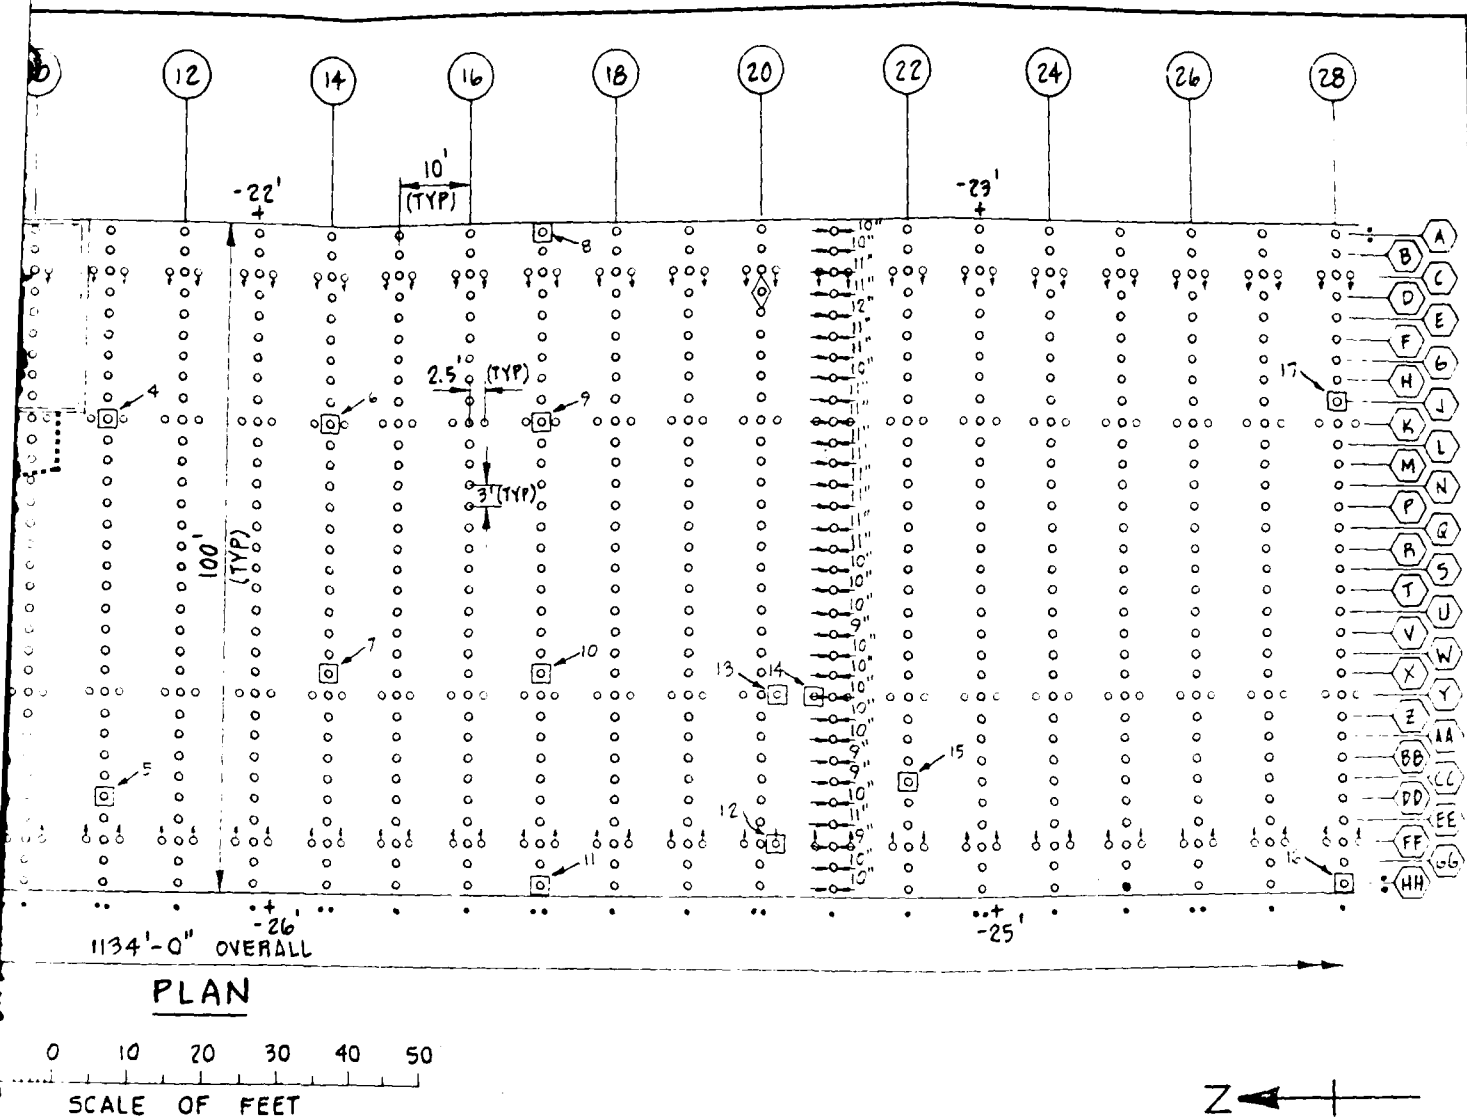
The anomalies can be located on Figures 39 through 42.

There are two locations on the pier (see Figures 39 and 41) that have a concrete sheet pile enclosure. The concrete sheet piling is deteriorating at El. -0.0. There is spalling of the corners of the piles and reinforcing steel is exposed. Generally, for the length of the concrete sheet piling the concrete is approximately 1/4" soft. In four locations below the stationary crane (see Figure 41), there are large gaps in the sheet pile wall. An attempt was made at one time to plug these gaps. The method of repair used concrete bags placed in the gap. These repairs are ineffective and fill is still leaching out from behind the wall, leaving large void spaces behind the wall.

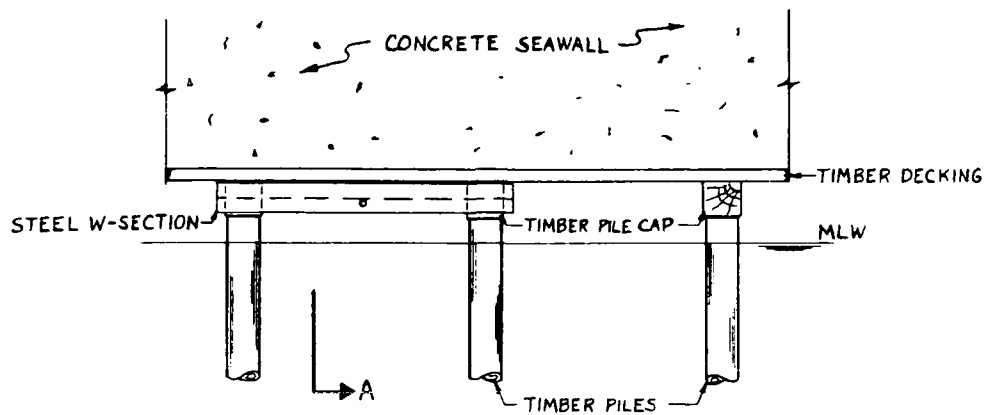
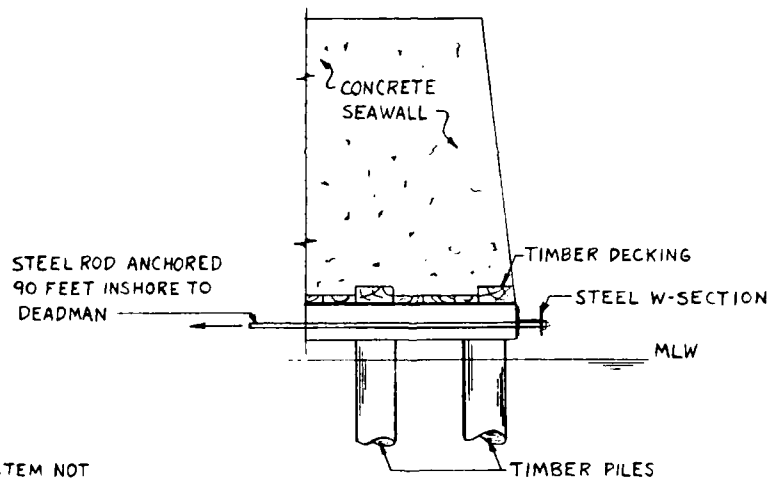
## PIER 2 TIE-BACK SYSTEM

IN CONCLUSION, ALTHOUGH THE SEAWALL HAS ROTATED CLOCKWISE AND THE TIMBER SHEET PILE WALL DEFLECTED OUTWARD, THE SYSTEM IS IN EQUILIBRIUM. THE LATERAL EARTH FORCE OF 10.9 TONS IS RESISTED BY THE HORIZONTAL COMPONENT OF THE BATTER PILE PLUS THE SHEAR STRENGTH OF THE TIMBER SHEET PILE WALL. NOTE THAT THE SHEAR STRENGTH OF THE TIMBER SHEET PILE WALL (5.7 TONS) IS NOT EXCEEDED BY THE SHEAR FORCE ACTING ON IT (3.9 TONS). HOWEVER, THE CONDITION LIMITS THE SURCHARGE THAT CAN BE PLACED BEHIND THE SEAWALL TO 0 PSF.

A POSSIBLE SOLUTION IS ILLUSTRATED ON PAGE A-31. THE INSTALLATION OF A DEADMAN AND TIE-BACK SYSTEM ACCORDING TO THE SOIL CONDITIONS FOUND IN THE FIELD WOULD RELIEVE THE PRESSURE BEING TRANSLATED TO THE VERTICAL BEARING PILES.
